ANALYSIS OF REHABILITATION PRIORITY OF IRRIGATION INFRASTRUCTURE

Fatchan Nurrochmad
Senior lecturer, Civil and Environmental Engineering Department, Faculty of Engineering
Gadjah Mada University, Jl. Grafika 2 Yogyakarta 55281.
E-mail: fatchan_nurr@yahoo.com

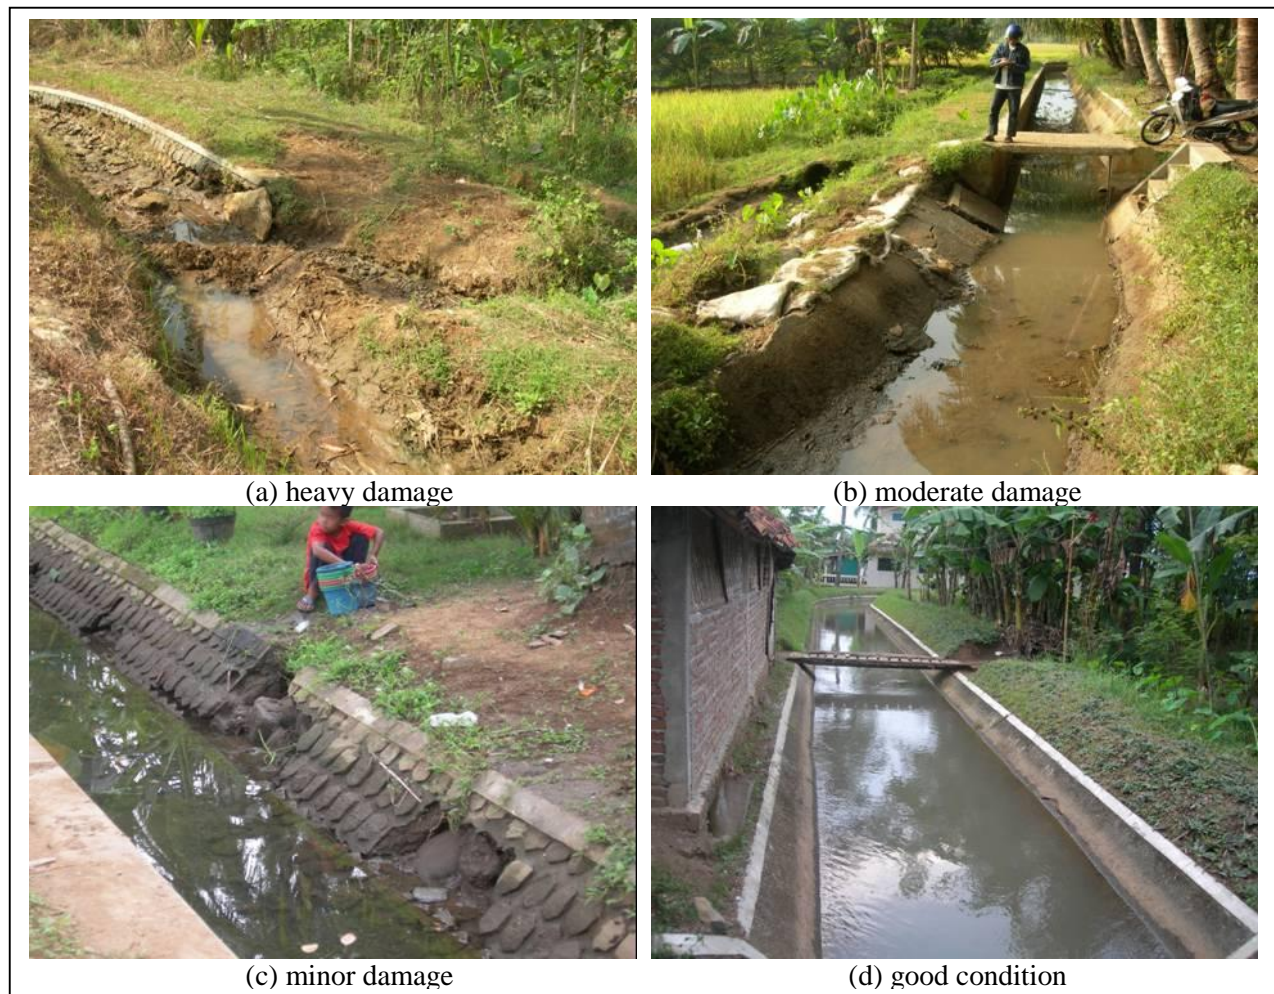
Figure 2. The channel damage condition.

Total damaged irrigation infrastructure was based on the assessment to weirs, channels, division structures, embankment and inspection road, and discharge measurement structures. Damaged condition was scored based on Table 4 to 8 and classified according to Table 9. Examples of severe damage (total disfunction to irrigating), average damage (part of irrigation water cannot flow through the channels), minor damage (normal irrigation

function but with some damages) and no damage with excellent flowing function are presented in Figure 2.
