# FUNDAMENTAL STUDY OF INTERNAL CRACK MEASUREMENT ON CONCRETE STRUCTURES BY USING STICK SCANNER

Achfas Zacoeb

Lecturer, Civil Engineering Department – Brawijaya University, Indonesia

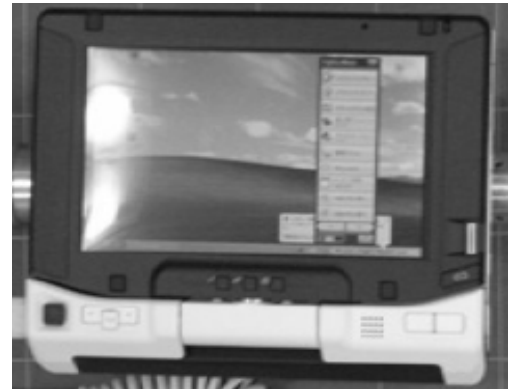
Figure 7. Tablet PC

Tablet PC that used in this experiment is FMV series as shown in Figure 7 with the weight of 580gr. For touch sensitive-ness, a tablet PC can be performed. When image capturing is processed, the scanning image can be displayed and analyzed by touching a monitor. This display monitor size is 5.5" and can be rotated in the arbitrary directions.
